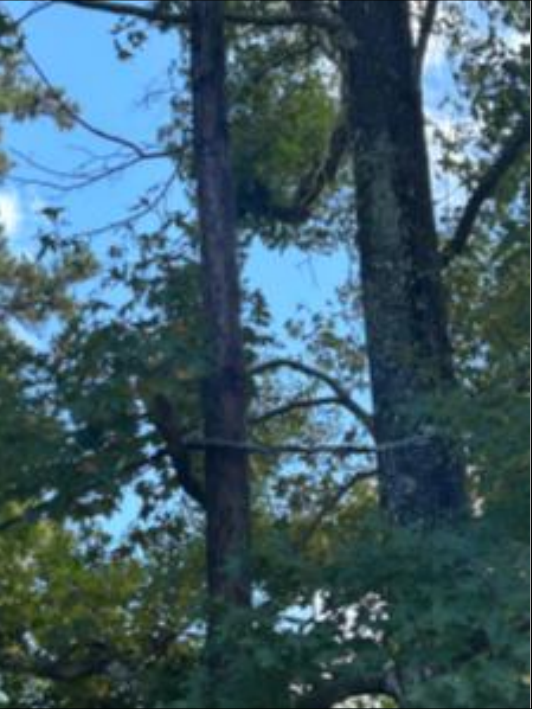
| Observation Date | Observer | Line of Business | Hazard Identification Location | Company | Contractor | Project | Obs type | Hazard Short Description | Potential Hazards | Hazard Detailed Description | Able to Correct or Mitigate | Corrective or Mitigation Methods | Work Order Created | Work Order Number | Follow Up Requested | Photo Link | Photo |
|---|---|---|---|---|---|---|---|--|---|---|---|--|---|---|---|---|---|
| 10/2/23 7:14 AM | | Transmission/Distribution | STSC | Cleco | | STSC | Good Catch | Drop hanging in tree. Broke off from pole | Electrical - Electrical Contact with Source, Electrical - Arc Flash | Low drop going to business. Wedge clamps broke. 4/0 service | Yes | Rehung service to the pole | No | | No | Photo Link | |

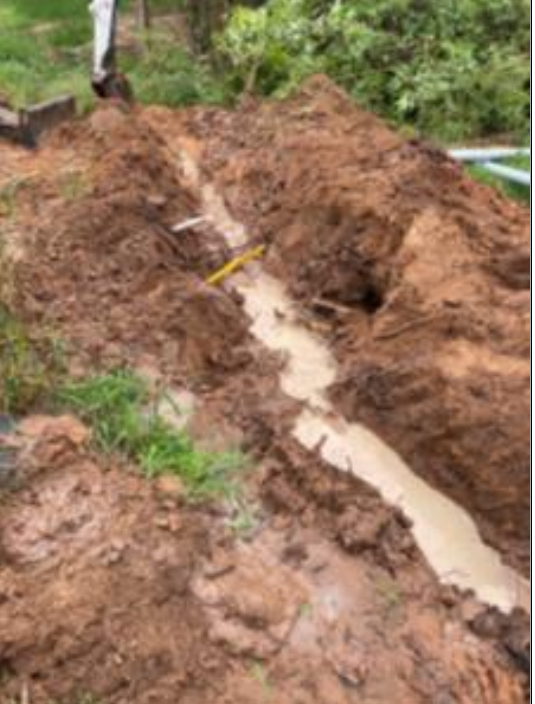
| Observation Date | Observer | Line of Business | Hazard Identification Location | Company | Contractor | Project | Obs type | Hazard Short Description | Potential Hazards | Hazard Detailed Description | Able to Correct or Mitigate | Corrective or Mitigation Methods | Work Order Created | Work Order Number | Follow Up Requested | Photo Link | Photo |
|---|---|---|---|---|---|---|---|--|---|---|---|--|---|---|---|---|---|
| 10/12/23 9:45 AM | | Transmission/Distribution | BUSC | Cleco | | | Near Miss | Hit Gas and Water Line When Digging URD | Pressure - Explosion | While digging a trench to install URD conduit, the crew busted a gas and water line. Both of which were on the customers property and not properly identified or communicated by the customer.. | Yes | The crew determined that the gas line had not been connected, verified with Rapides Parish Utilities. And they were able to quickly shutoff the water. Both lines were repaired after the digging was completed. | N/A | | No | Photo Link | |

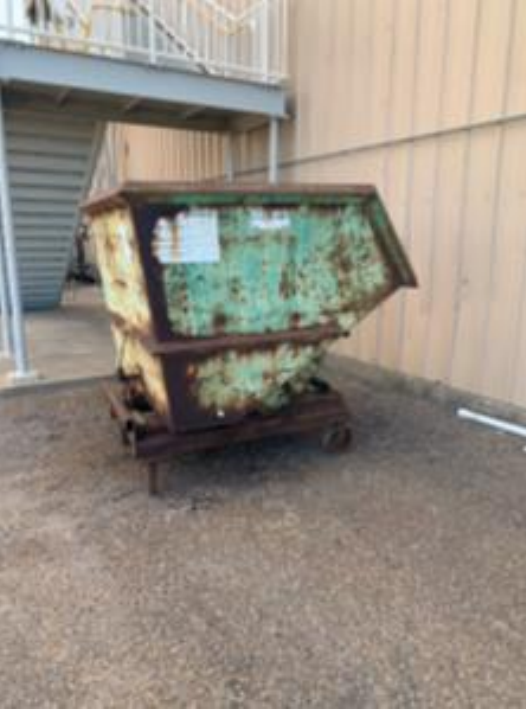
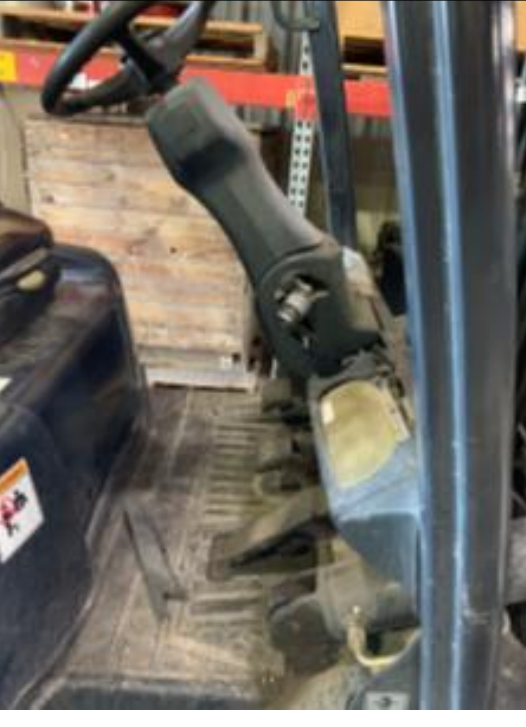
| Observation Date | Observer | Line of Business | Hazard Identification Location | Company | Contractor | Project | Obs type | Hazard Short Description | Potential Hazards | Hazard Detailed Description | Able to Correct or Mitigate | Corrective or Mitigation Methods | Work Order Created | Work Order Number | Follow Up Requested | Photo Link | Photo |
|---|---|---|---|---|---|---|---|--|---|---|---|---|---|---|---|---|--|
| 10/16/23 9:52 AM | | Generation | ACPS | Cleco | | | Near Miss | Near Miss: Material fell from elevated position. | Gravity - Suspended Load | On Thursday 10-12-23 a Cleco employee was in the process of dumping crushed metal tote carriers into a large dumpster. The crushed metal tote carriers were in a dumpster that tilts forward when it is unlatched and raised. The employee unlatched the dumpster so it could tilt forward, and raised the dumpster. The employee had gotten of the forklift, that is when they observed a crushed metal tote carrier slide backwards towards the cab of the fork truck and crack the ignition switch housing. Employee was not on the forklift and no injuries occurred. | Yes | Employees tagged forklift out of service and ordered a rental. Employees were instructed to use lull if trash bin is full of material that could potentially fall back and damage equipment or cause injury. Asked forklift vendor to provide quote on installing guard on truck to protect operator in case of material falling backward | No | | No | Photo Link | |
| 10/16/23 9:52 AM | | Generation | ACPS | Cleco | | | Near Miss | Near Miss: Material fell from elevated position. | Gravity - Suspended Load | On Thursday 10-12-23 a Cleco employee was in the process of dumping crushed metal tote carriers into a large dumpster. The crushed metal tote carriers were in a dumpster that tilts forward when it is unlatched and raised. The employee unlatched the dumpster so it could tilt forward, and raised the dumpster. The employee had gotten of the forklift, that is when they observed a crushed metal tote carrier slide backwards towards the cab of the fork truck and crack the ignition switch housing. Employee was not on the forklift and no injuries occurred. | Yes | Employees tagged forklift out of service and ordered a rental. Employees were instructed to use lull if trash bin is full of material that could potentially fall back and damage equipment or cause injury. Asked forklift vendor to provide quote on installing guard on truck to protect operator in case of material falling backward | No | | No | Photo Link | |

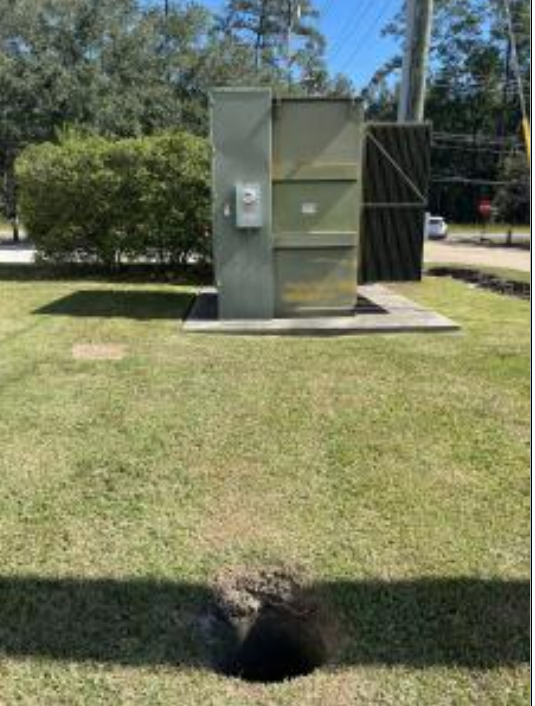
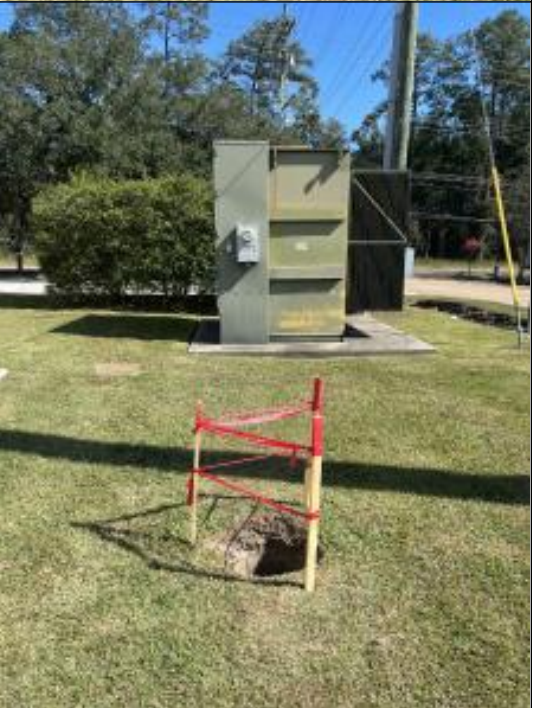
| Observation Date | Observer | Line of Business | Hazard Identification Location | Company | Contractor | Project | Obs type | Hazard Short Description | Potential Hazards | Hazard Detailed Description | Able to Correct or Mitigate | Corrective or Mitigation Methods | Work Order Created | Work Order Number | Follow Up Requested | Photo Link | Photo |
|---|---|---|---|---|---|---|---|---|---|--|---|--|---|---|---|---|--|
| 10/17/23 2:47 PM | | Transmission/Distribution | STSC | Cleco | | | Good Catch | Man hole/abandoned sewer lift unbarricaded near Hunt Drive substation Pad | Gravity - Fall from Elevation, Pressure - Excavation or | 10-15 feet from Hunt Drive substation pad mount, man hole lid missing/uncovered causing fall/trip hazard. Believed by property owner to be abandoned sewer tank access point. Hole was approx. 30 inches in diameter and 24 inches deep. Property owner was not aware of hazard. | Yes | Placed stakes and red flagging tape to create barricade around man hole. Contacted tenant of property on site to get contact information for property owner. Contacted property owner via phone, informed him of hazard and barricade installed around man hole. Property owner will have hazard addressed ASAP. | N/A | | No | Photo Link | |
| 10/17/23 2:47 PM | | Transmission/Distribution | STSC | Cleco | | | Good Catch | Man hole/abandoned sewer lift unbarricaded near Hunt Drive substation Pad | Gravity - Fall from Elevation, Pressure - Excavation or | 10-15 feet from Hunt Drive substation pad mount, man hole lid missing/uncovered causing fall/trip hazard. Believed by property owner to be abandoned sewer tank access point. Hole was approx. 30 inches in diameter and 24 inches deep. Property owner was not aware of hazard. | Yes | Placed stakes and red flagging tape to create barricade around man hole. Contacted tenant of property on site to get contact information for property owner. Contacted property owner via phone, informed him of hazard and barricade installed around man hole. Property owner will have hazard addressed ASAP. | N/A | | No | Photo Link | |

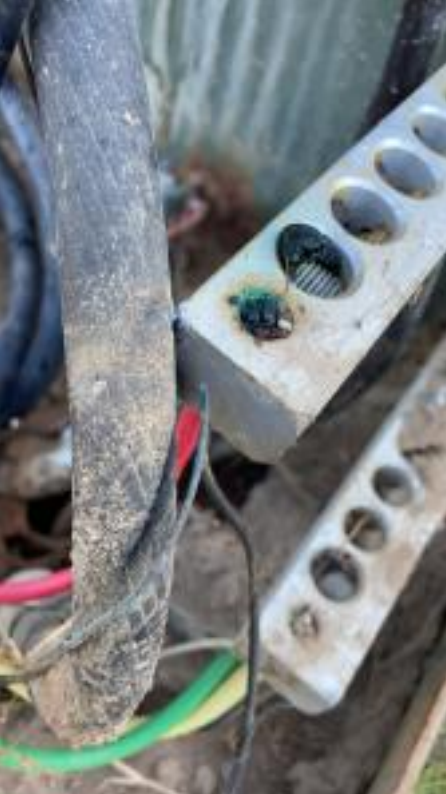
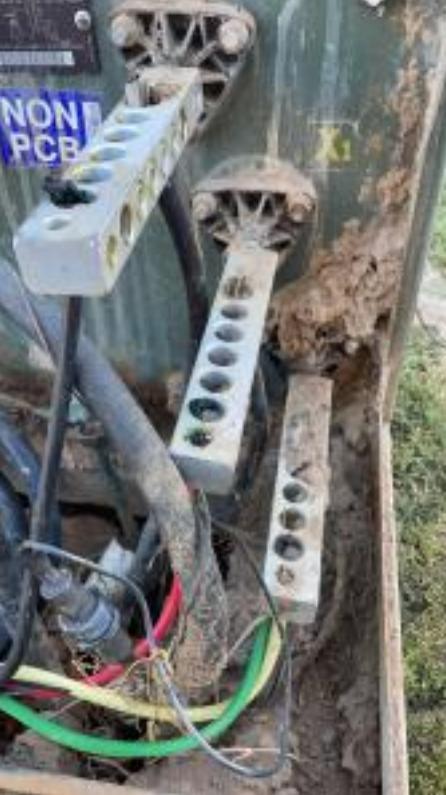
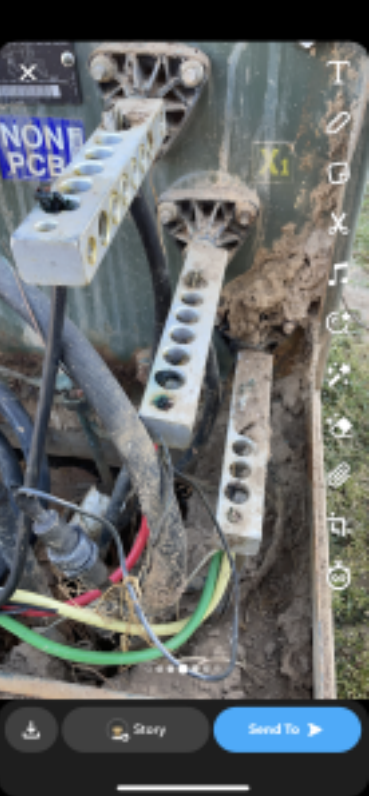
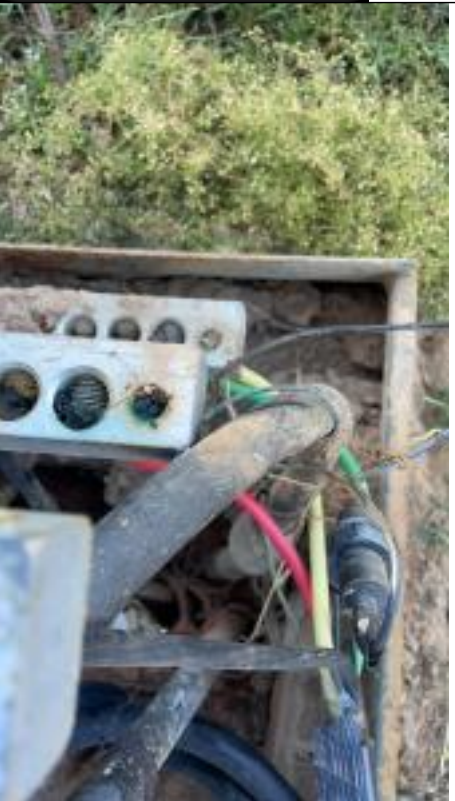
| Observation Date | Observer | Line of Business | Hazard Identification Location | Company | Contractor | Project | Obs type | Hazard Short Description | Potential Hazards | Hazard Detailed Description | Able to Correct or Mitigate | Corrective or Mitigation Methods | Work Order Created | Work Order Number | Follow Up Requested | Photo Link | Photo |
|---|---|---|---|---|---|---|---|--|---|--|---|---|---|---|---|---|---|
| 10/26/23 9:30 AM | | Transmission/Distribution | BUSC | Cleco | | Installing underground to homes | Good Catch | Bleeder laying on energized secondary | Electrical - Electrical Contact with Source, Electrical - Arc Flash | Bleeder ground was laying on energized secondary bushing | Yes | De energized transformer and cleared hazard | No | | No | Photo Link | |
| 10/26/23 9:30 AM | | Transmission/Distribution | BUSC | Cleco | | Installing underground to homes | Good Catch | Bleeder laying on energized secondary | Electrical - Electrical Contact with Source, Electrical - Arc Flash | Bleeder ground was laying on energized secondary bushing | Yes | De energized transformer and cleared hazard | No | | No | Photo Link | |

| Observation Date | Observer | Line of Business | Hazard Identification Location | Company | Contractor | Project | Obs type | Hazard Short Description | Potential Hazards | Hazard Detailed Description | Able to Correct or Mitigate | Corrective or Mitigation Methods | Work Order Created | Work Order Number | Follow Up Requested | Photo Link | Photo |
|---|---|---|---|---|---|---|---|---|---|--|---|---|---|---|---|---|--|
| 10/26/23 9:30 AM | | Transmission/Distribution | BUSC | Cleco | | Installing underground to homes | Good Catch | Bleeder laying on energized secondary | Electrical - Electrical Contact with Source, Electrical - Arc Flash | Bleeder ground was laying on energized secondary bushing | Yes | De energized transformer and cleared hazard | No | | No | Photo Link | |
| 10/26/23 9:30 AM | | Transmission/Distribution | BUSC | Cleco | | Installing underground to homes | Good Catch | Bleeder laying on energized secondary | Electrical - Electrical Contact with Source, Electrical - Arc Flash | Bleeder ground was laying on energized secondary bushing | Yes | De energized transformer and cleared hazard | No | | No | Photo Link | |
