# CLECO POWER LLC DOLET HILLS POWER STATION

CCR ANNUAL INSPECTION

ASH BASIN NO. 1

JANUARY 2025

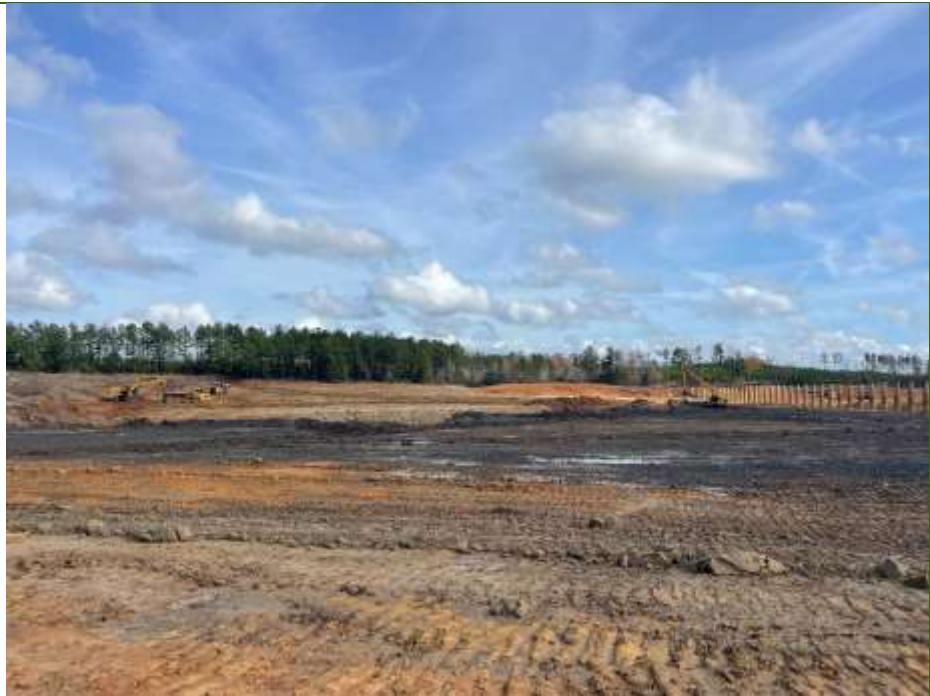
**Ash Basin No. 1**

Northern portion of Ash Basin No. 1

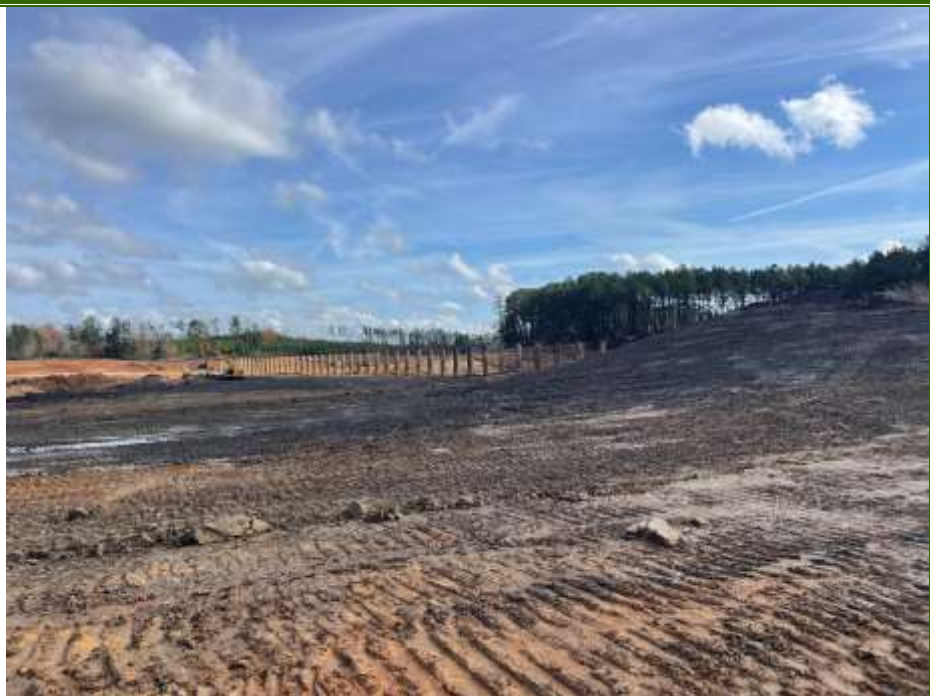
**Ash Basin No. 1**

Final grading of floor of ash basin. Former sluice structure in background.

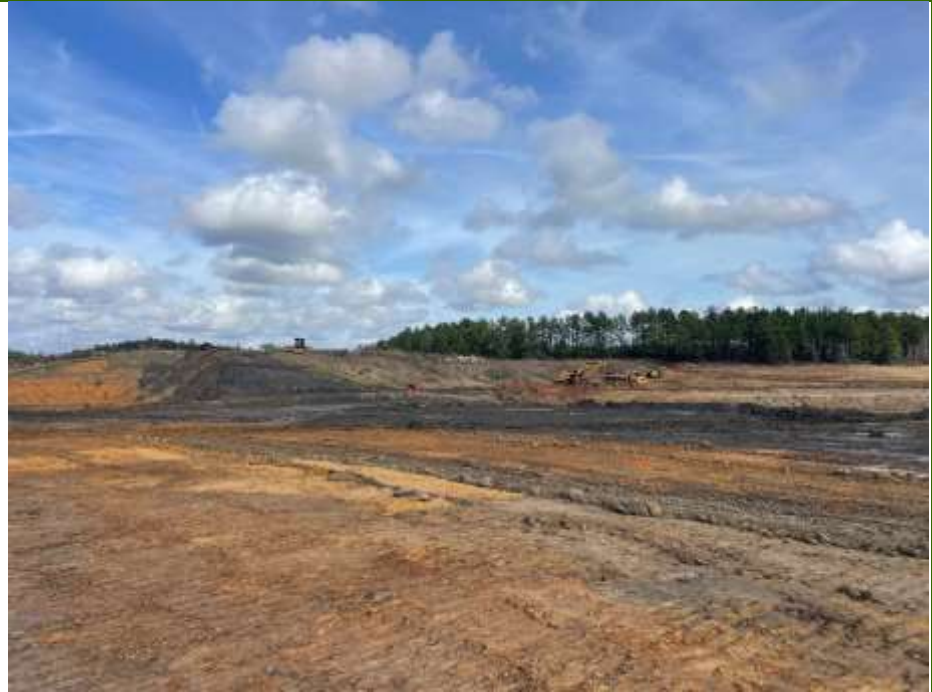
**Ash Basin No. 1**

**Comments:**  
Final grading of ash basin to support drainage.
