CLECO POWER LLC DOLET HILLS POWER STATION

CCR ANNUAL INSPECTION

ASH BASIN NO. 2

JANUARY 2025

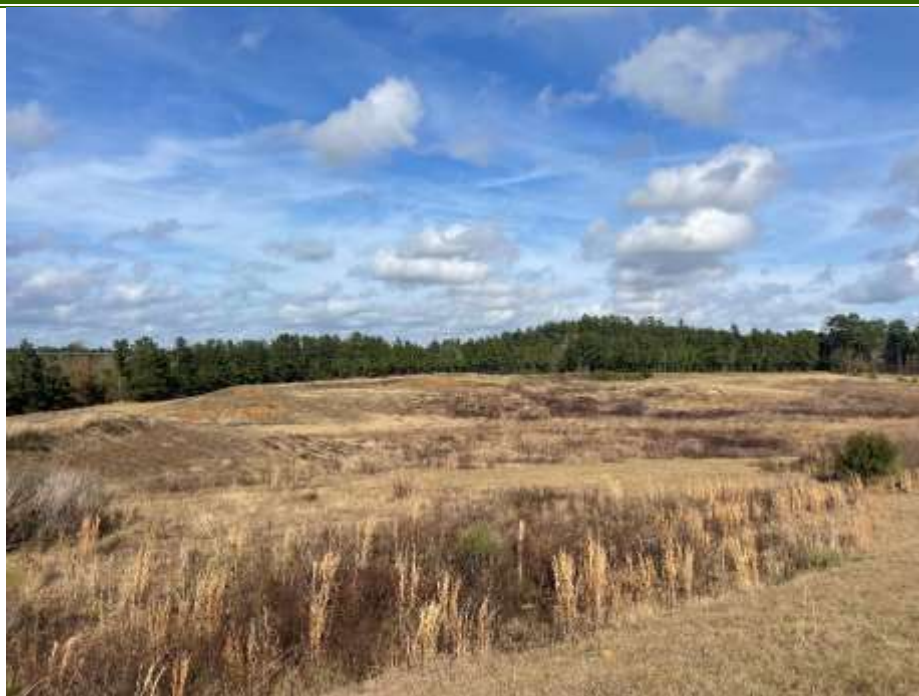
Ash Basin No. 2

North

Northern portion of A-2 Basin and vegetation.

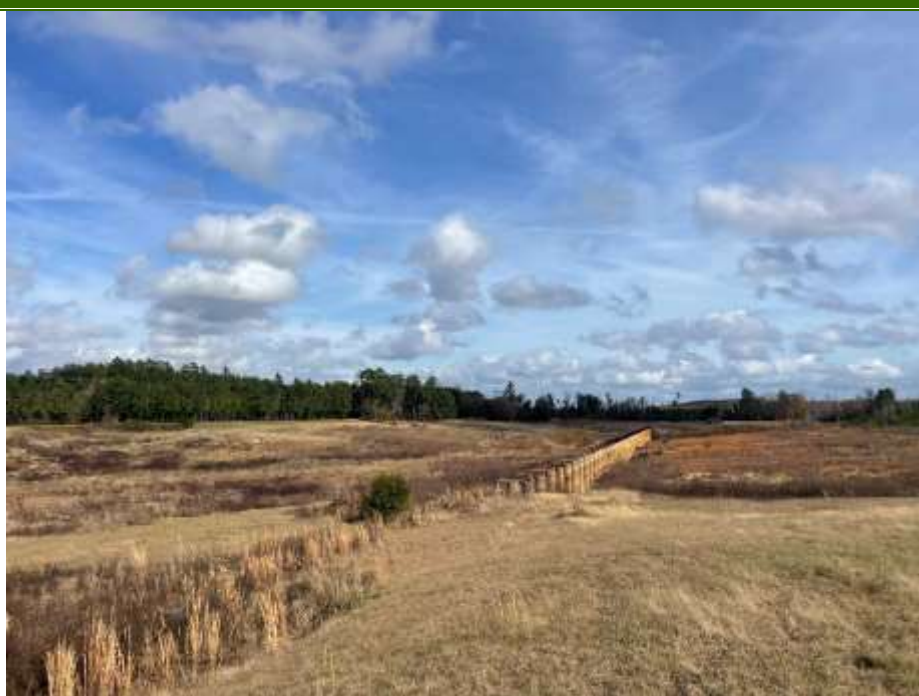
Ash Basin No. 2

Northeasterly

Old ash sluice structure. The majority of ash basin footprint vegetated.

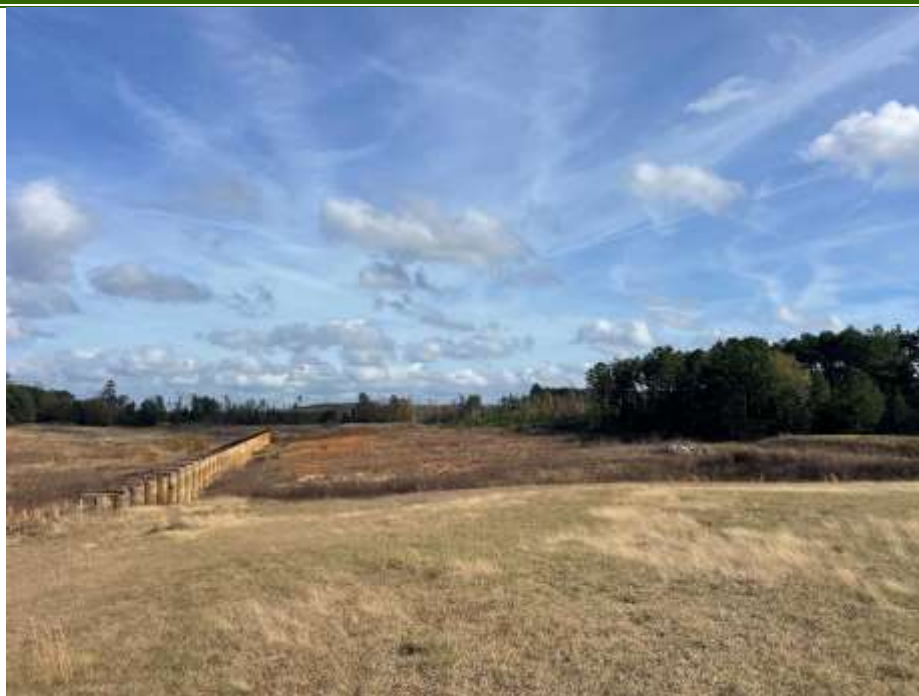
Ash Basin No. 2

Easterly

Former ash sluice structure
