CLECO POWER LLC DOLET HILLS POWER STATION

CCR ANNUAL INSPECTION

FLY ASH/SCRUBBER SLUDGE LANDFILL

JANUARY 2025

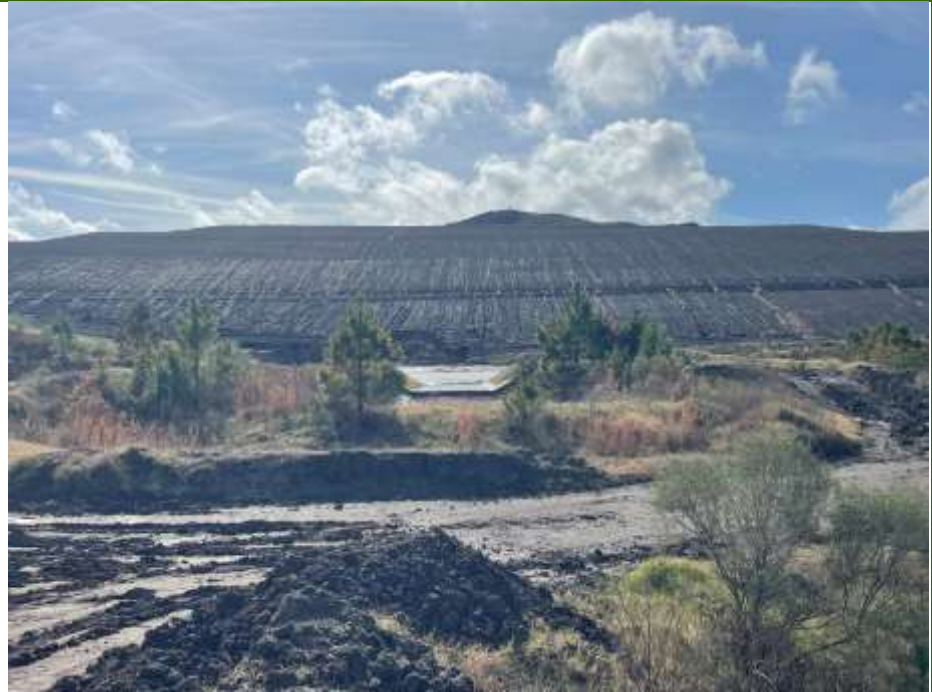
Outfall structure at North edge of landfill.

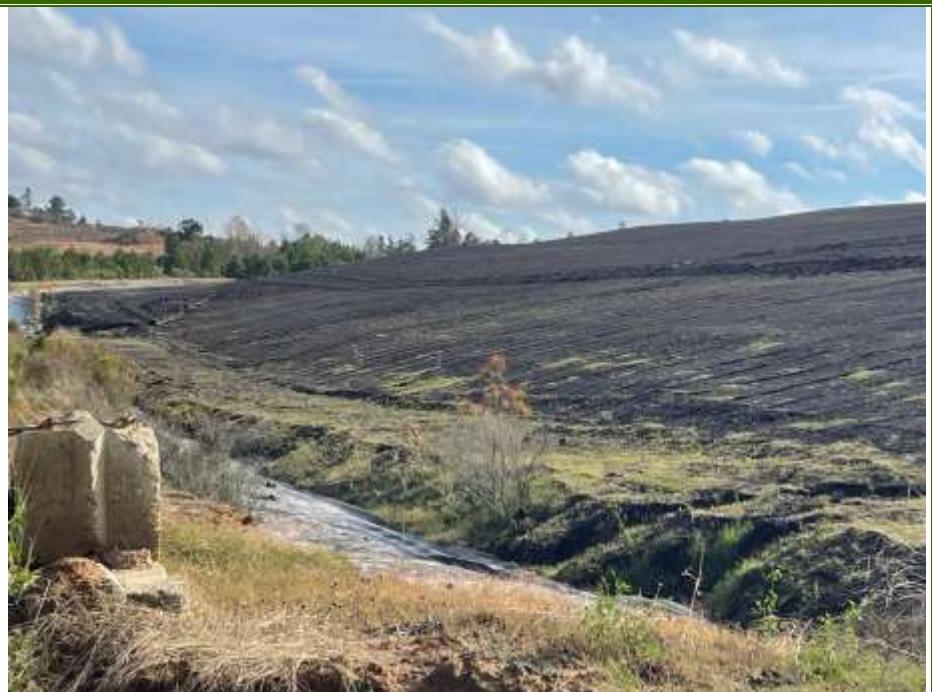
North side and slope of landfill.

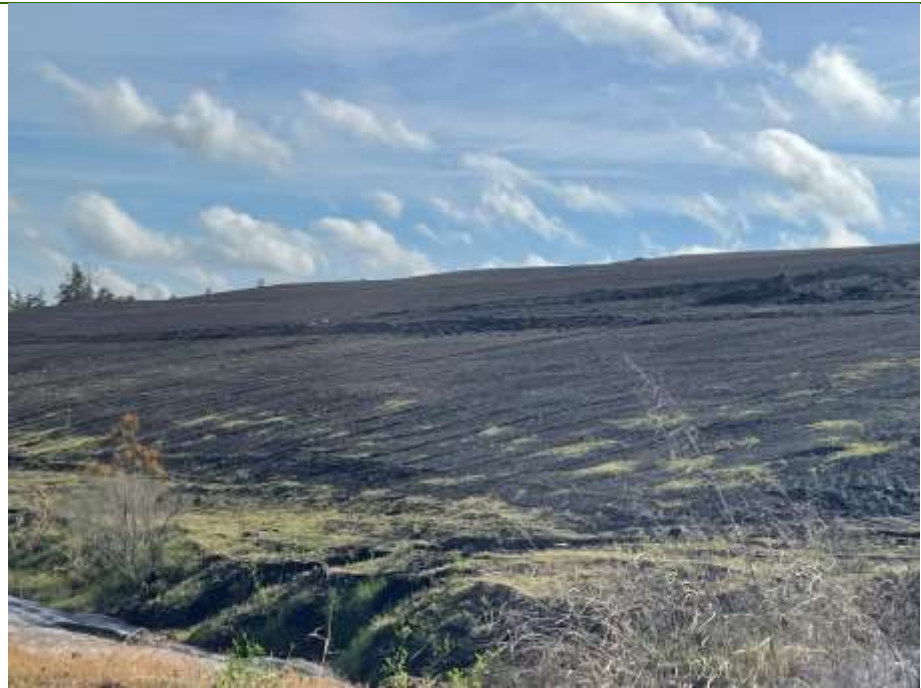
North slope of landfill.

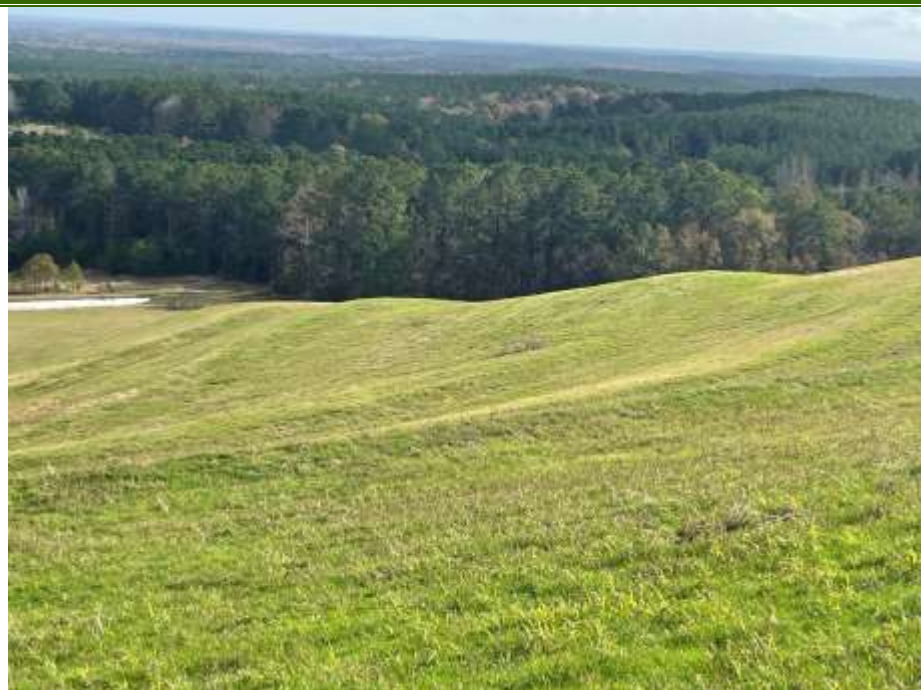
Southeast slope of landfill. Lined drainage channel in background.

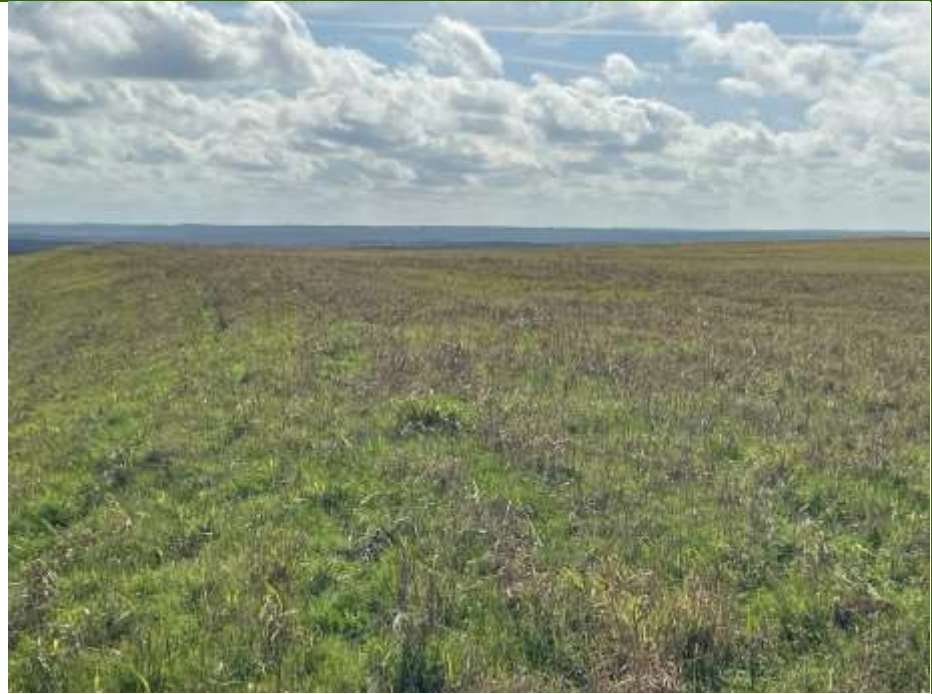
Top of landfill cap.

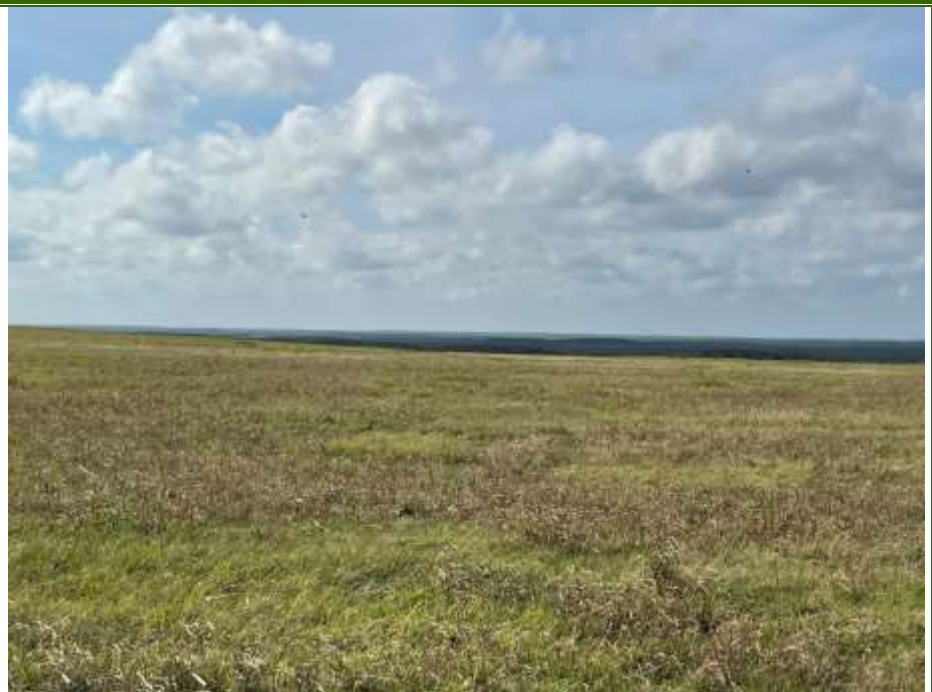
Top of landfill cap.

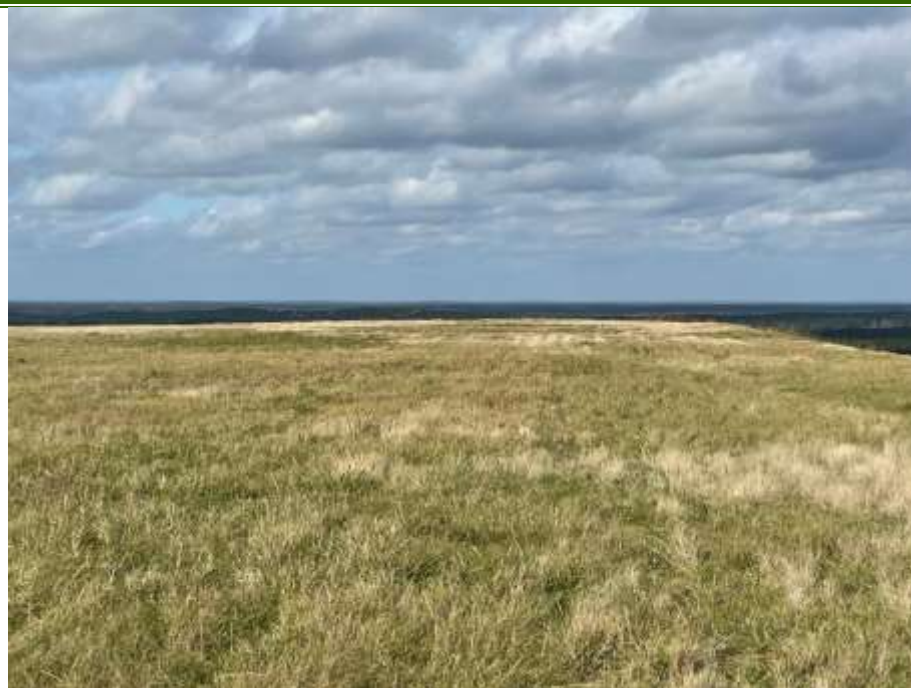
Top of landfill cap.

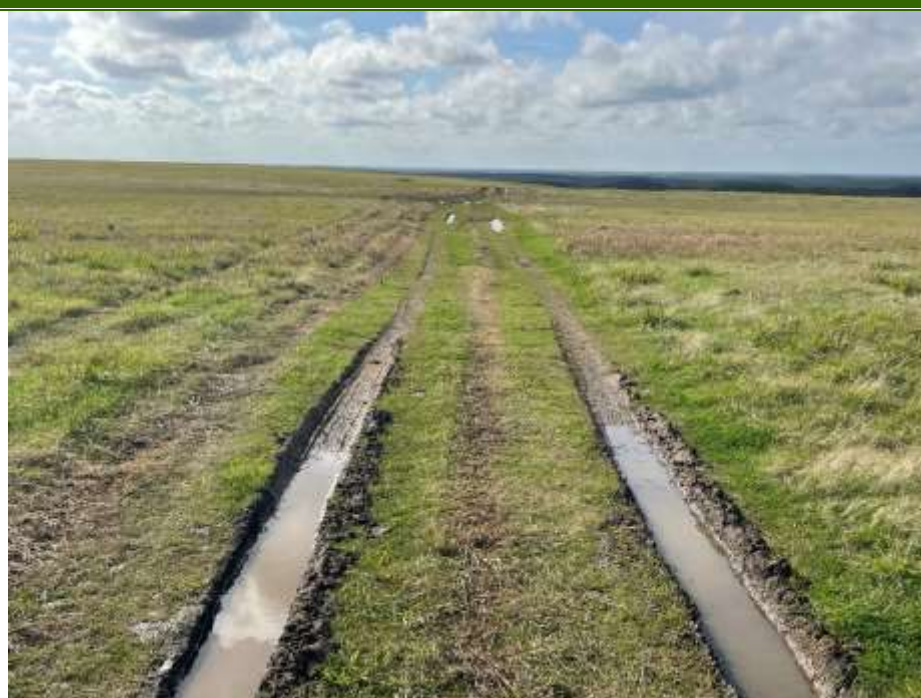
Findings:	The upper elevation flat cap area was inspected and appeared to be in satisfactory condition. Some minor rutting where vehicles have been traveling.
Other observations on the upper elevation flat cap area:	None

Top of landfill cap, some shallow rutting along landfill cap access road.

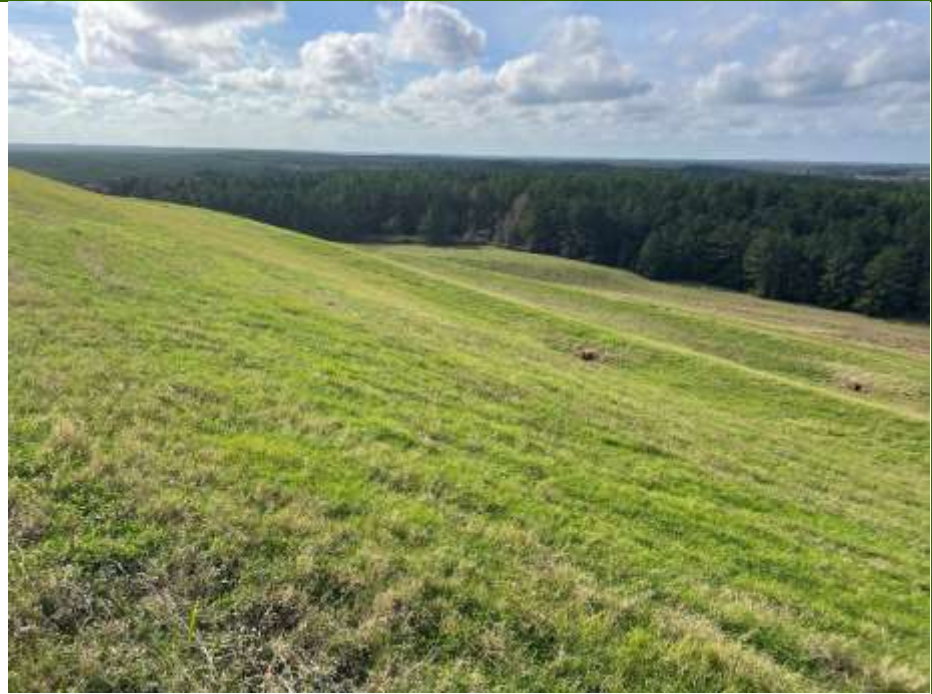
Southeast slope of landfill.

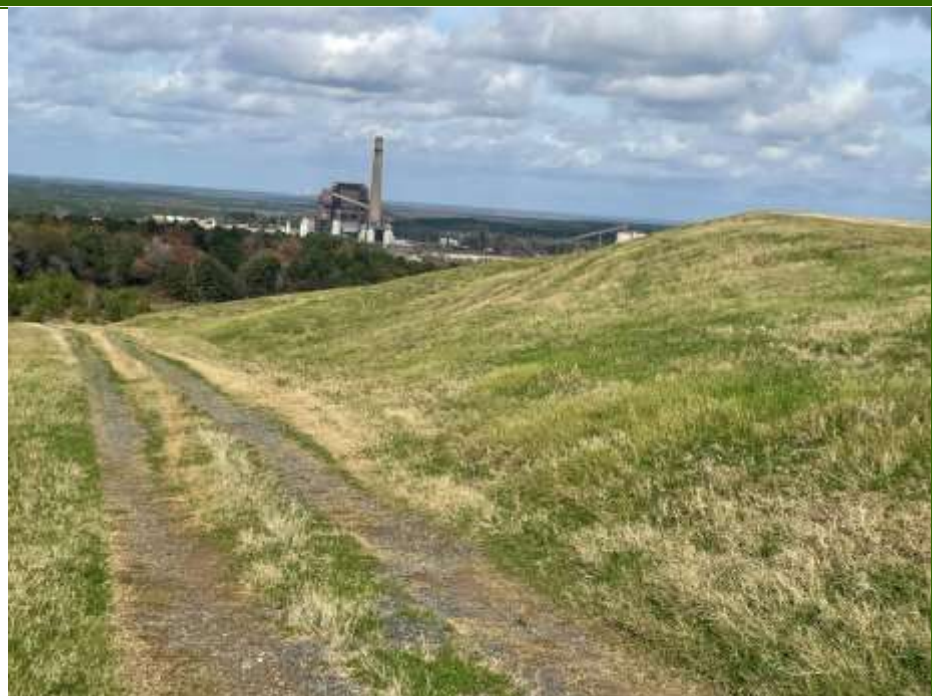
West slope of landfill, access road.

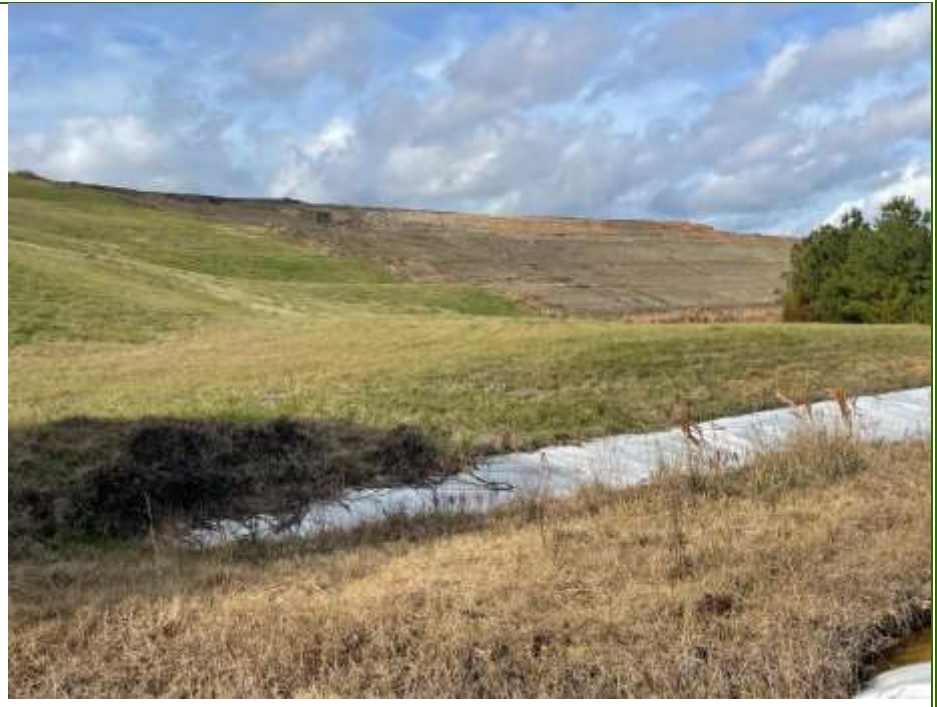
East slope of landfill.

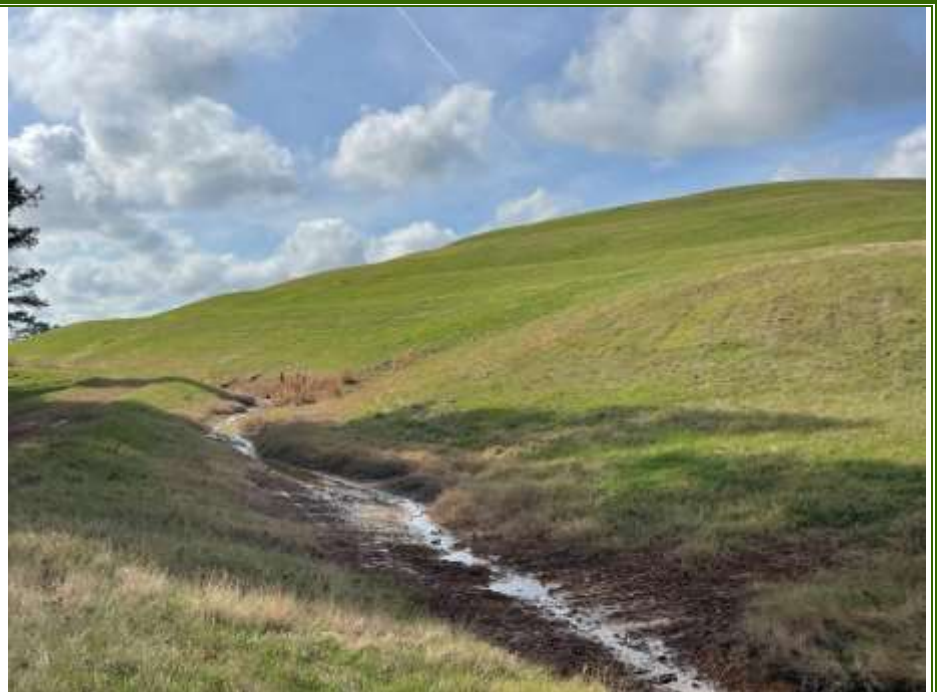
East slope of landfill.

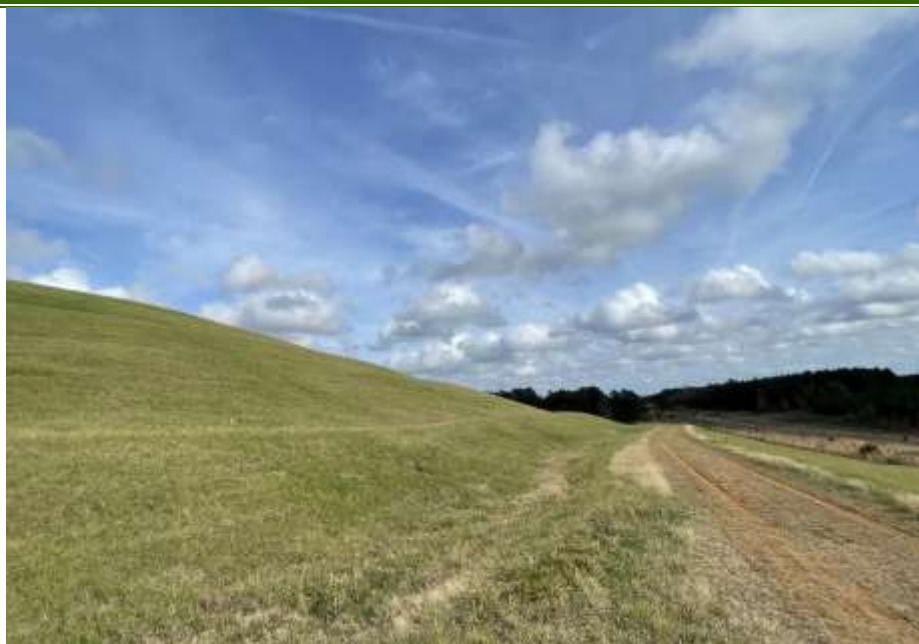
South slope of landfill.

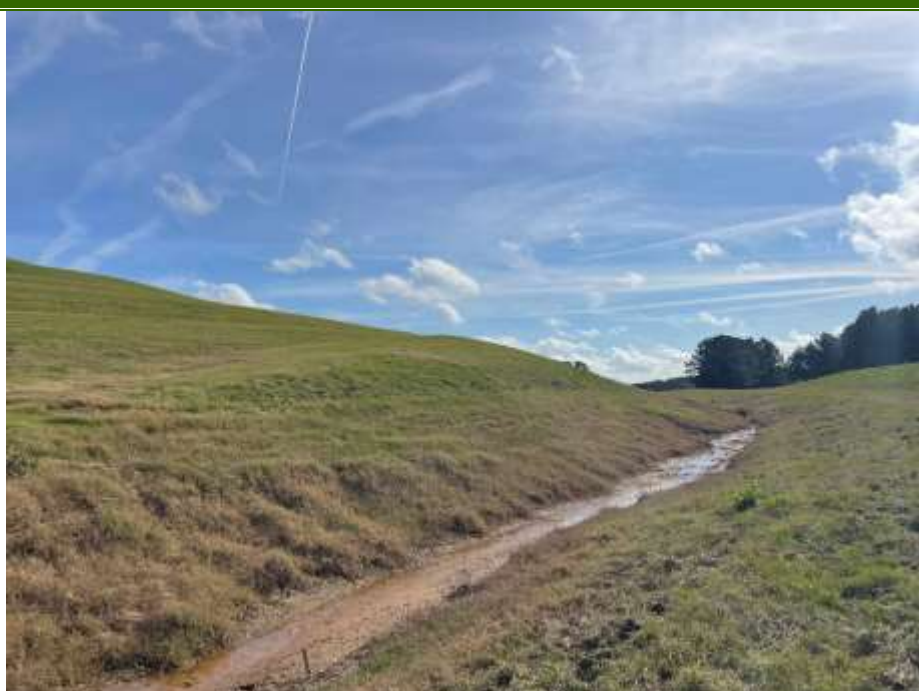
West slope of landfill and perimeter ditch.

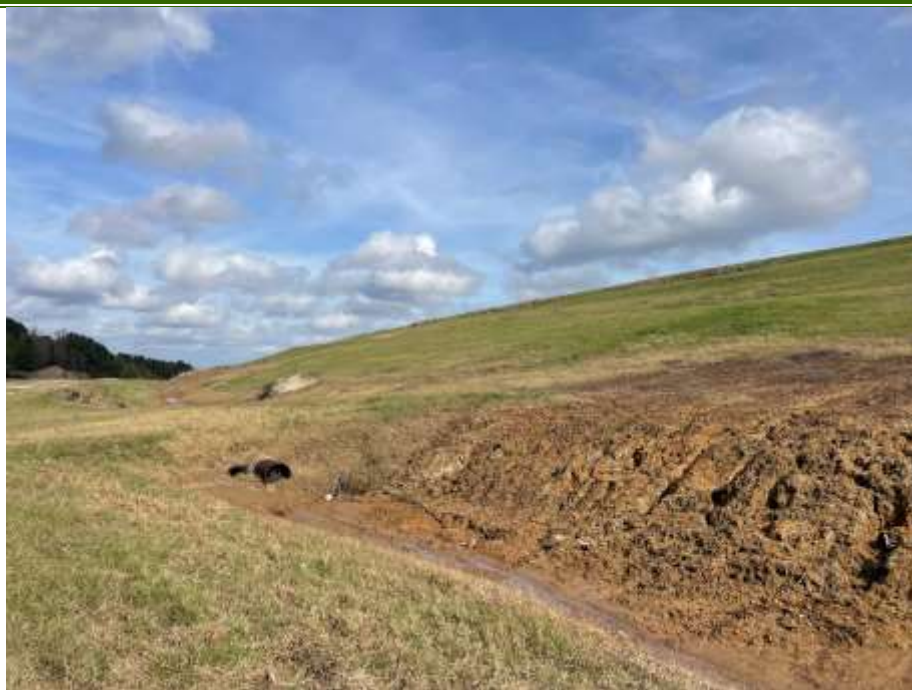
Use of reinforced downchutes and buried pipe downchutes	
Is the stormwater infrastructure in good condition?	<input checked="" type="checkbox"/> Yes <input type="checkbox"/> No
Findings:	The exterior slopes were inspected and appeared to be in fair to good condition. Wet areas and some seepage and erosion on west slope above perimeter ditch.
Other observations on the exterior slopes:	None

West slope of landfill.
Ditch crossing. Some erosion on landfill side ditch slope.

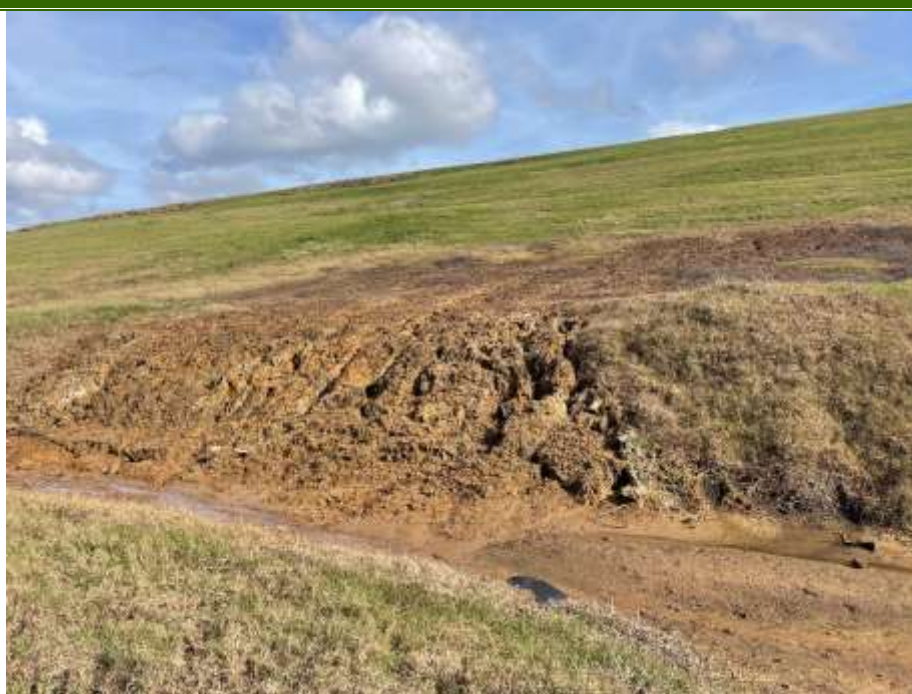
West slope of landfill.
Erosion along ditch slope.
