CLECO POWER LLC BRAME ENERGY CENTER

CCR ANNUAL INSPECTION

LANDFILL—CELL 4

JANUARY 2025

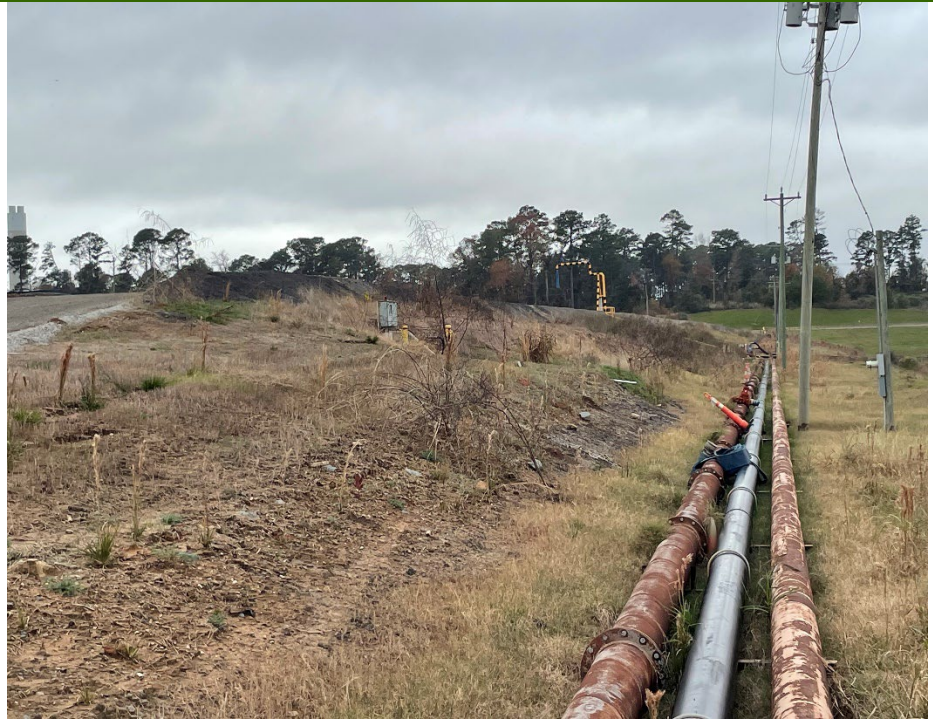
Landfill Cell 4

Direction:
Northwesterly

Comments:
Sluice lines between eastern edge of cell 4 and Bottom Ash Pond. Vegetation needs to be managed.

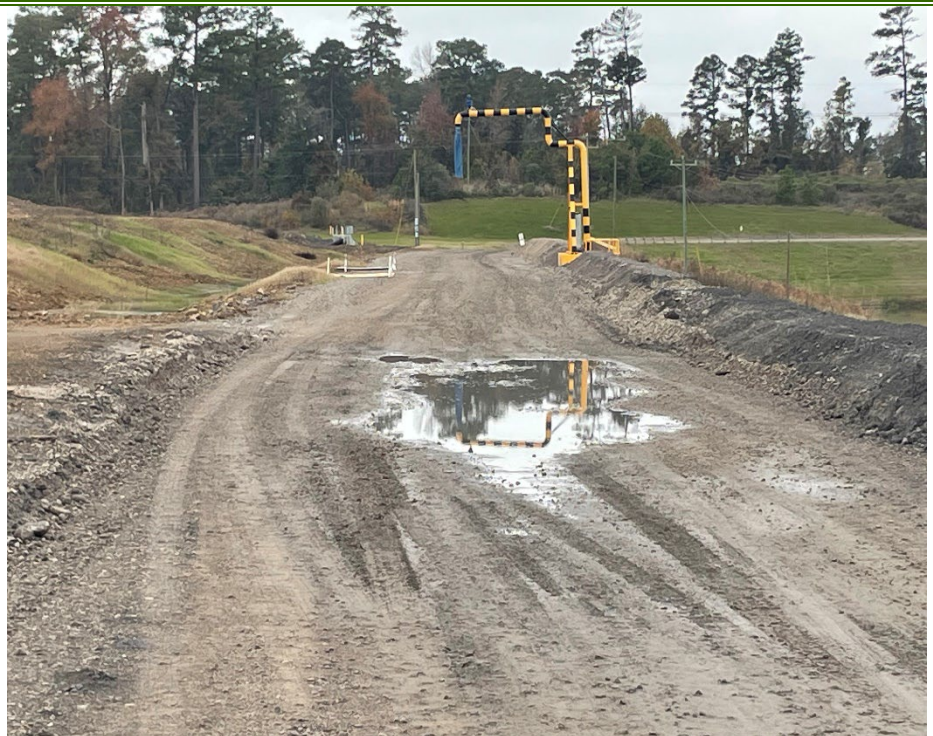
Landfill Cell 4

Direction:
Northeasterly

Comments:
Access road on east side of Landfill Cell 4.

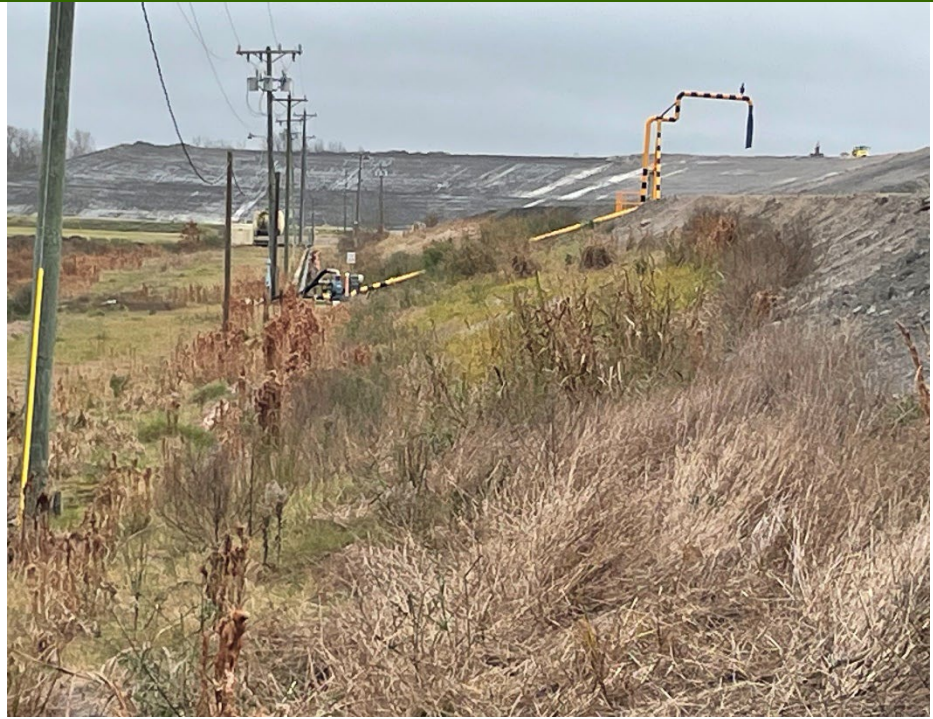
Landfill Cell 4

Direction:
Southeasterly

Comments:
Cell 4 embankment between cell 4 and bottom ash pond. Vegetation needs to be managed.

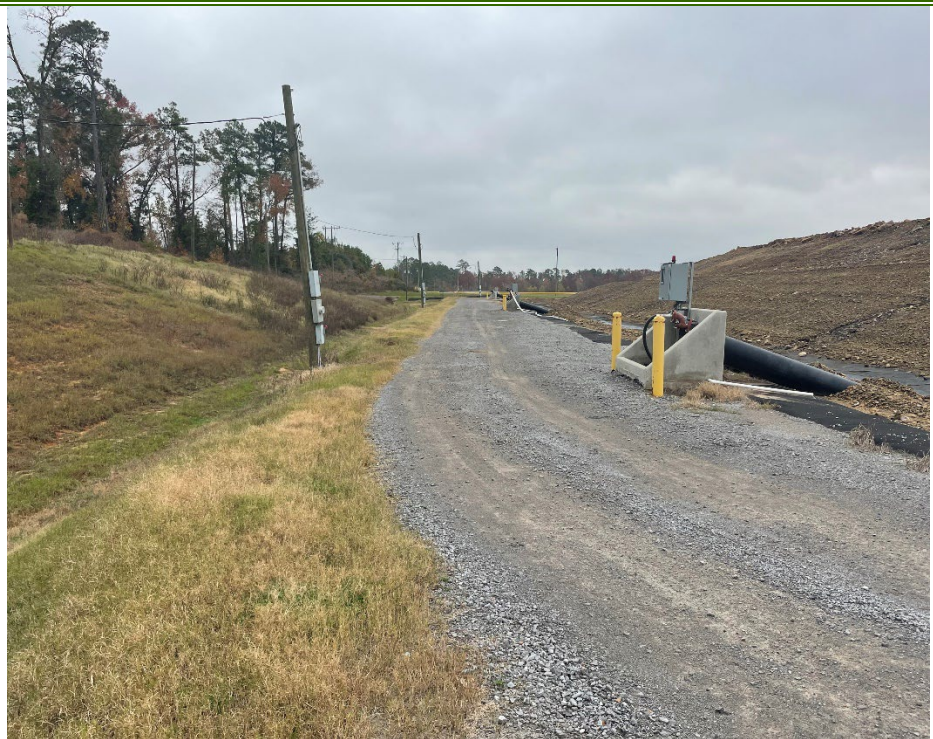
Landfill Cell 4

Direction:
Northeasterly

Comments:
Northwest slope, leachate extraction risers, interior ditch, and access road

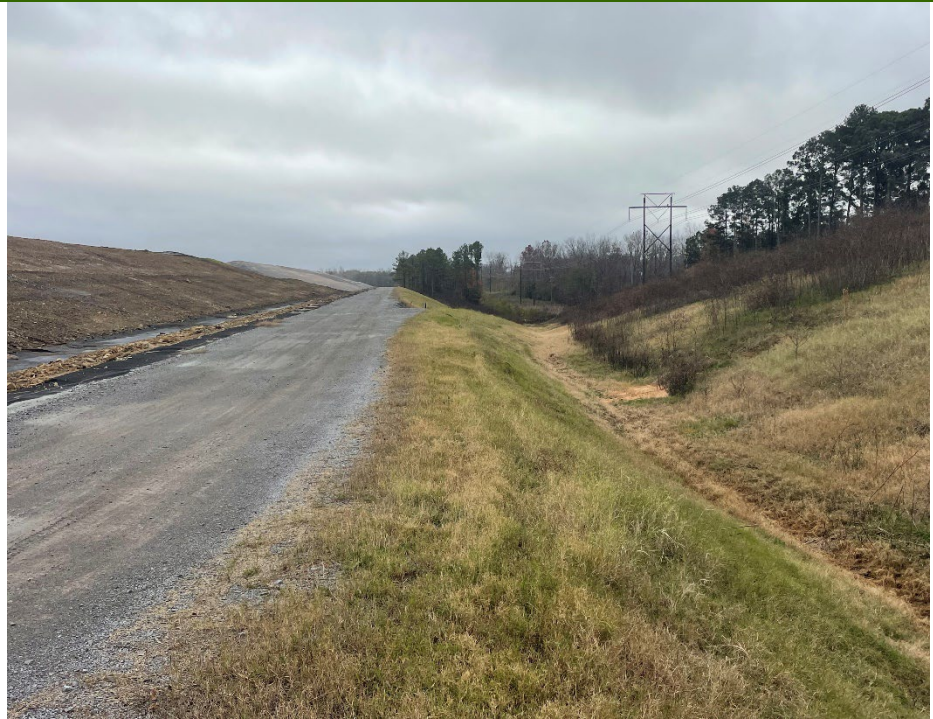
Landfill Cell 4

Southeasterly

Western levee
access road interior
ditch and exterior
slope

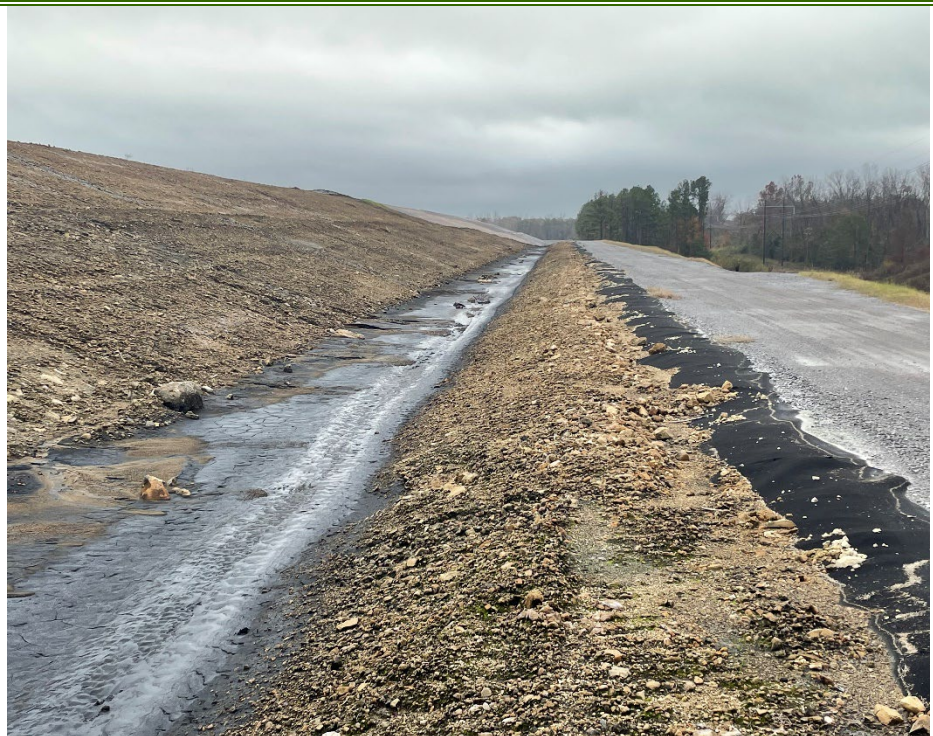
Landfill Cell 4

Southeasterly

Western levee
access road and
interior ditch

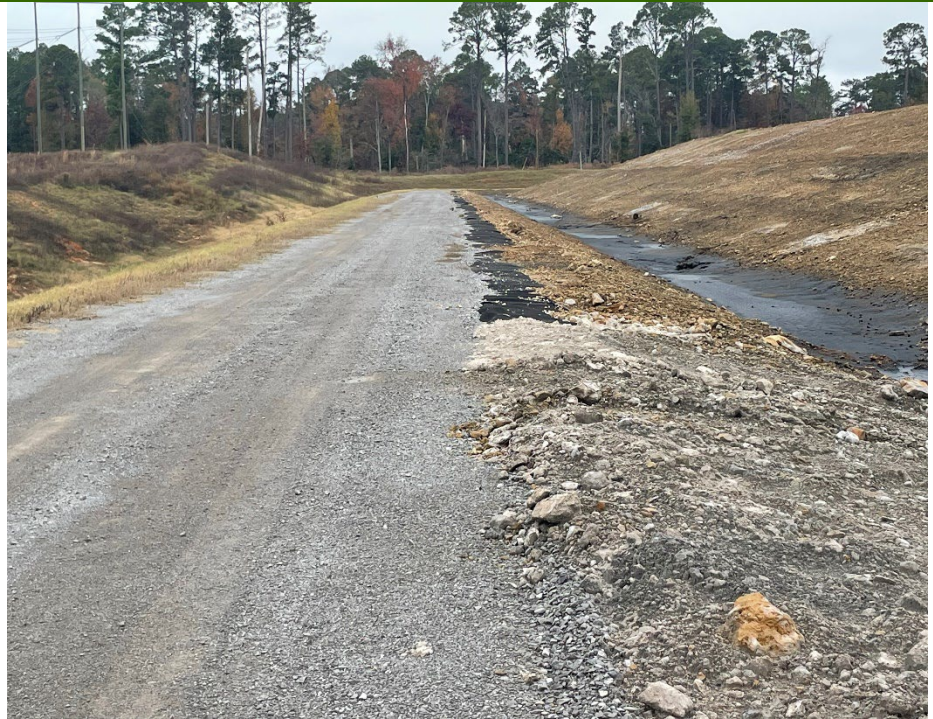
Landfill Cell 4

Northwesterly

Western levee access road and interior ditch

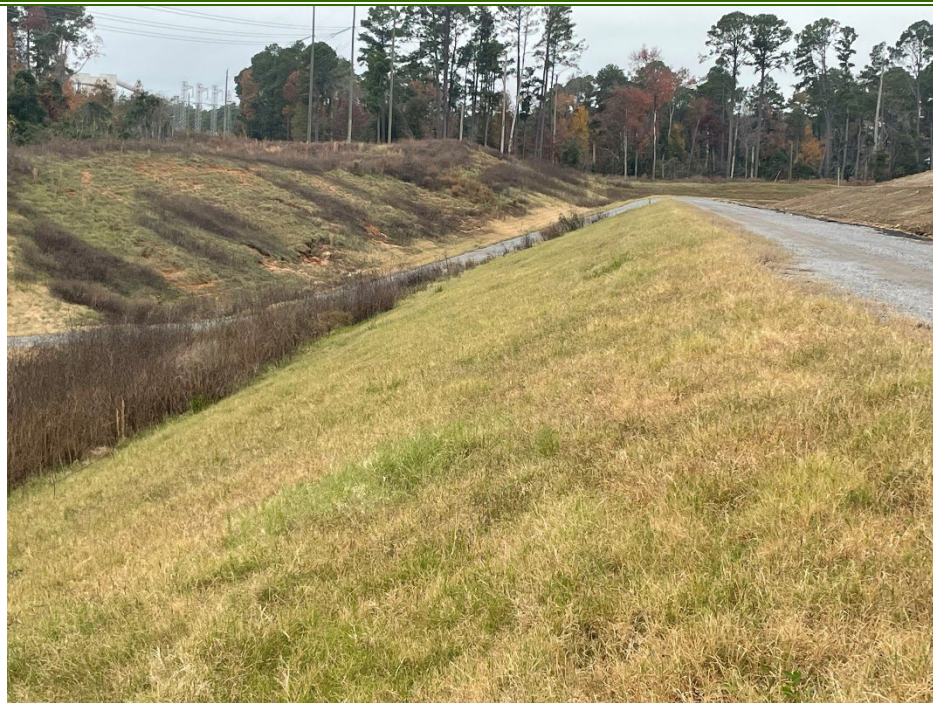
Landfill Cell 4

Northwesterly

Access road and exterior slope
