CLECO POWER LLC BRAME ENERGY CENTER

CCR ANNUAL INSPECTION

BOTTOM ASH POND

JANUARY 2025

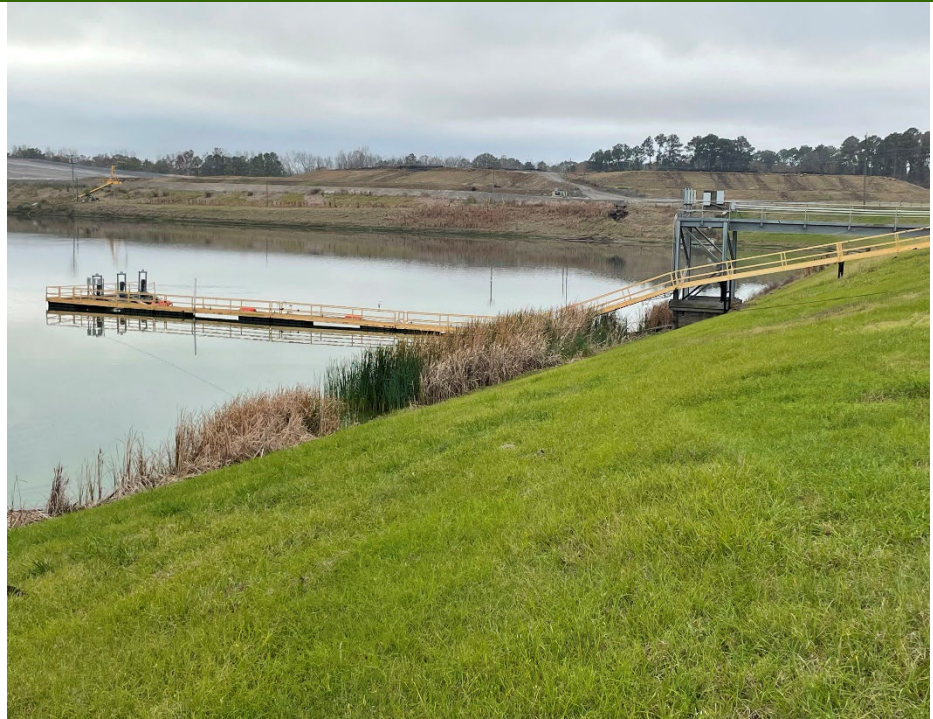
Pond discharge structure

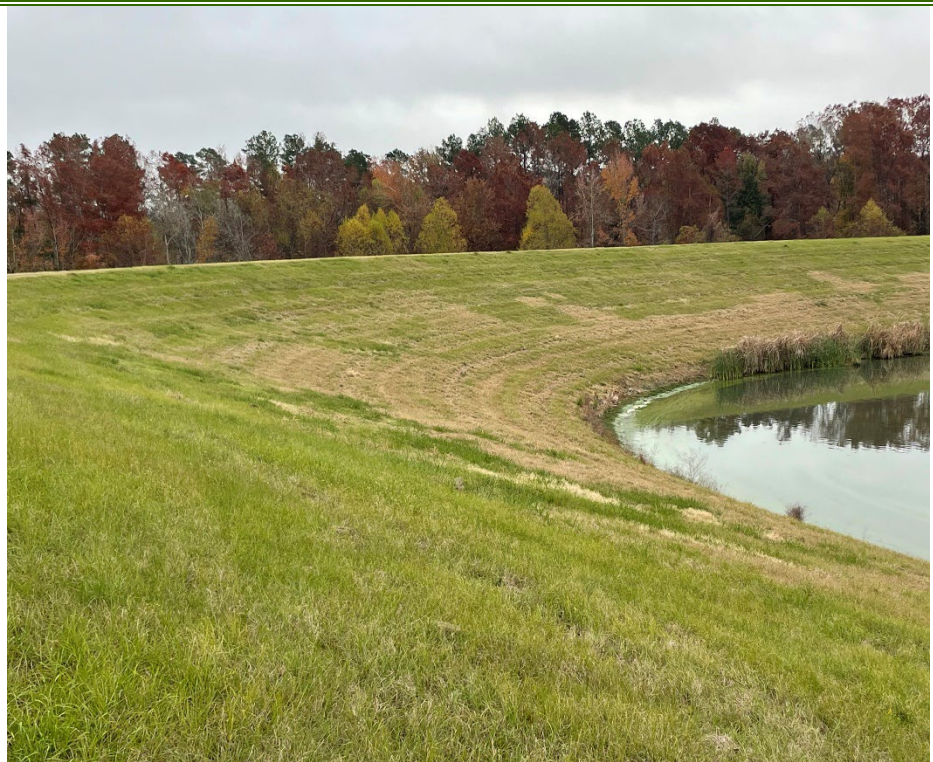
North levee slope

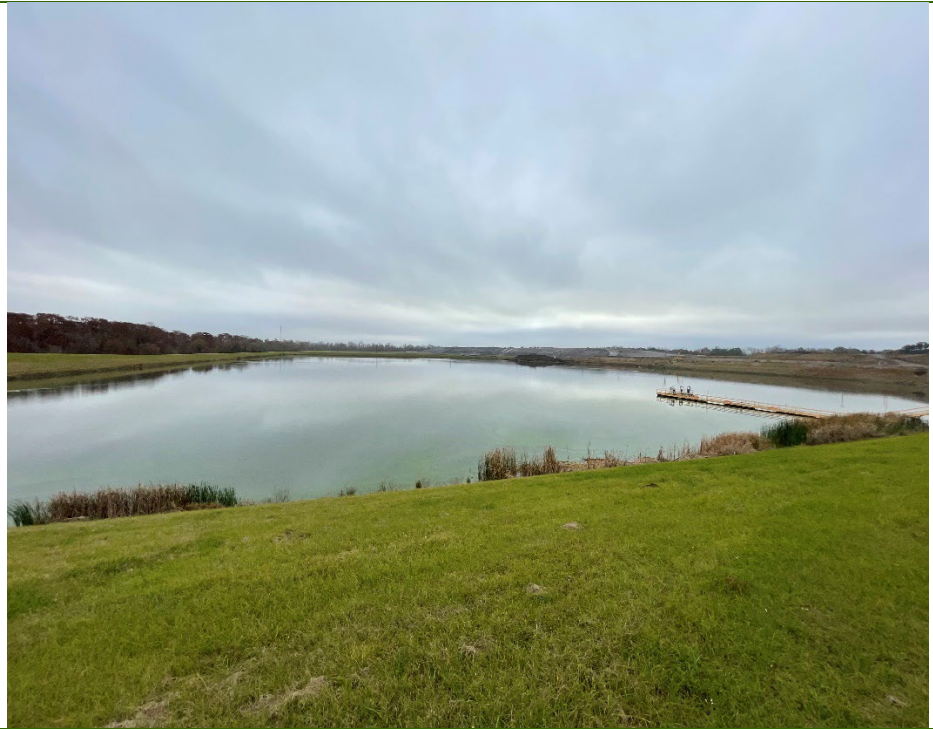
Southern facing
overview

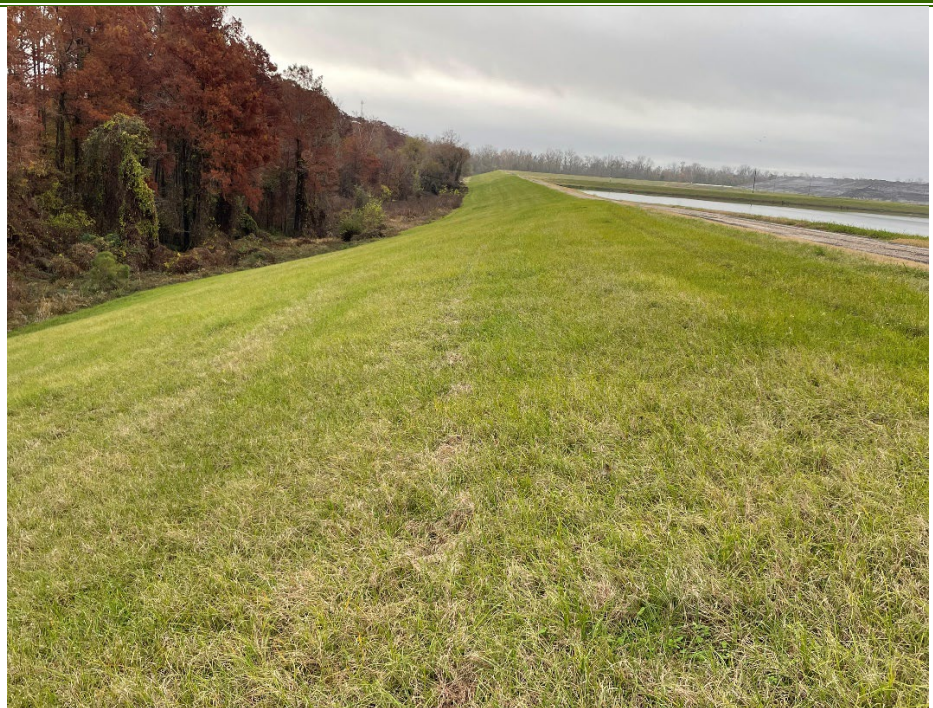
Eastern levee
exterior slope

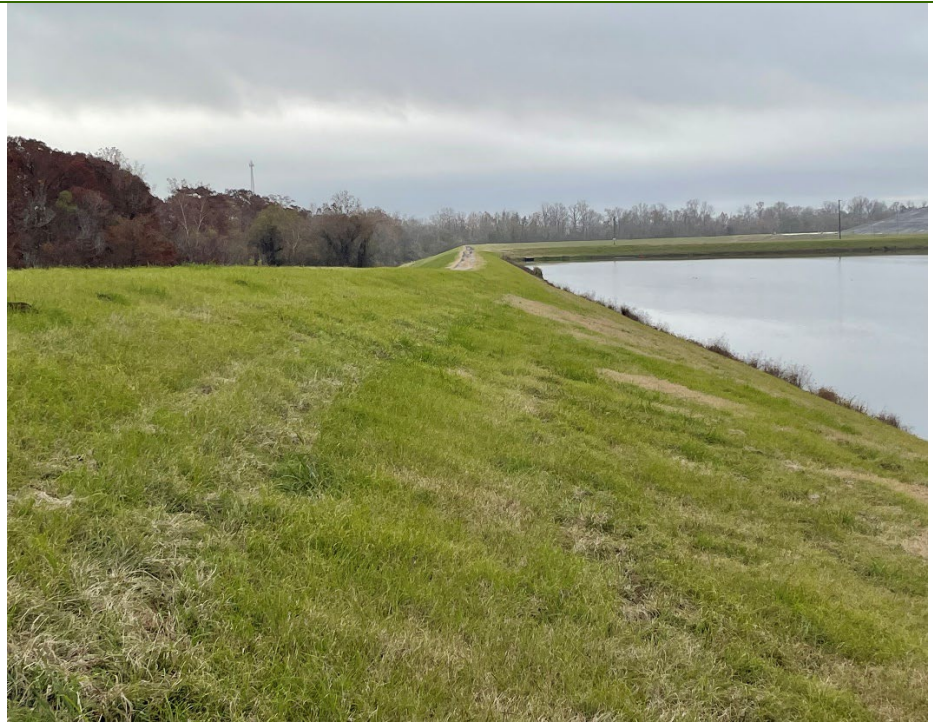
Eastern levee inside slope

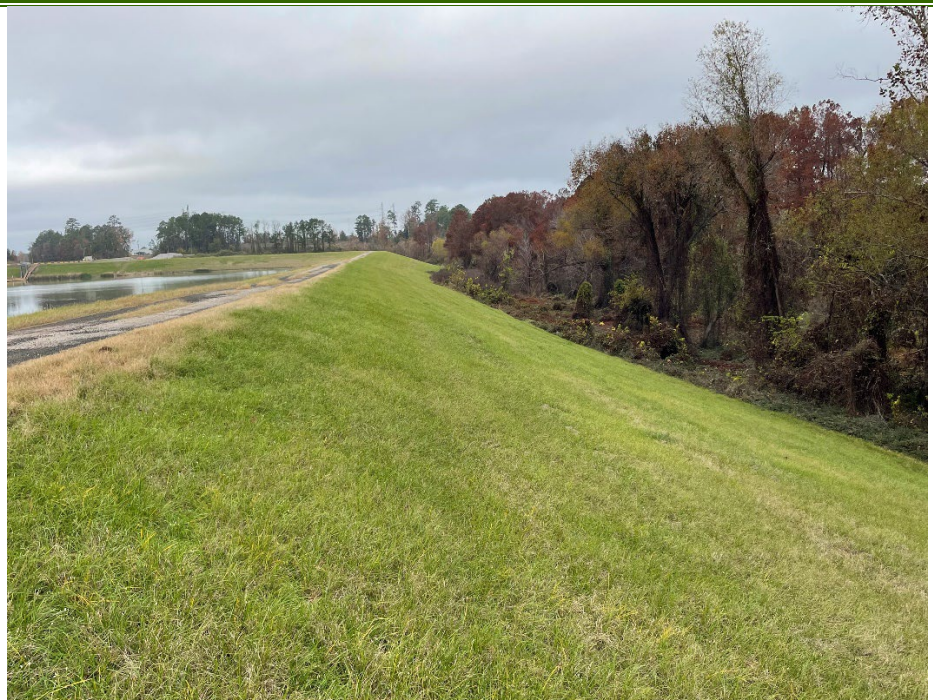
Eastern levee outside slope

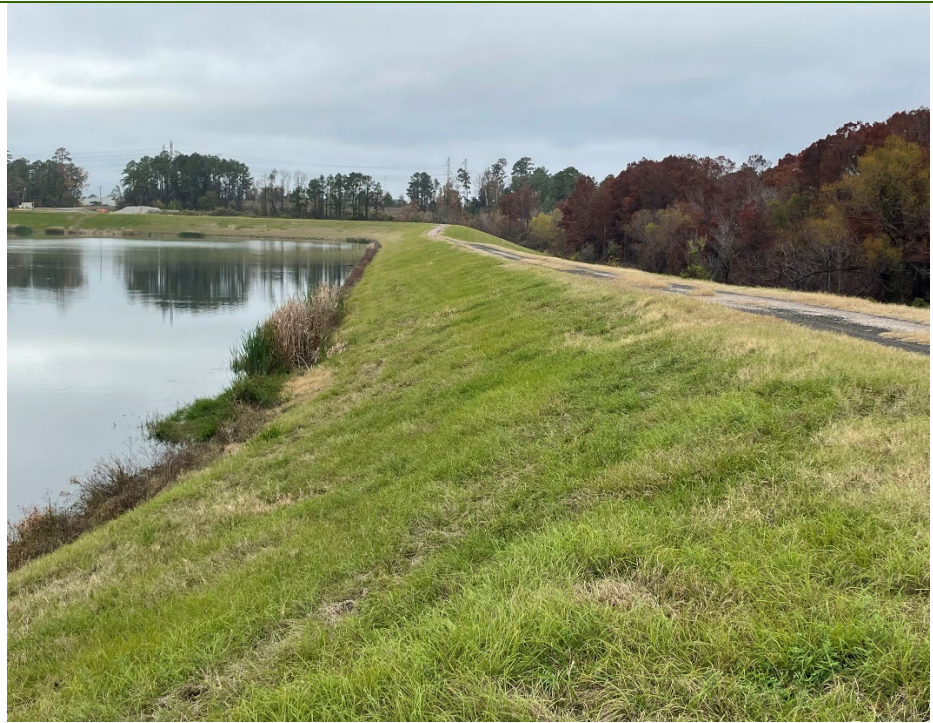
Eastern levee,
inside slope

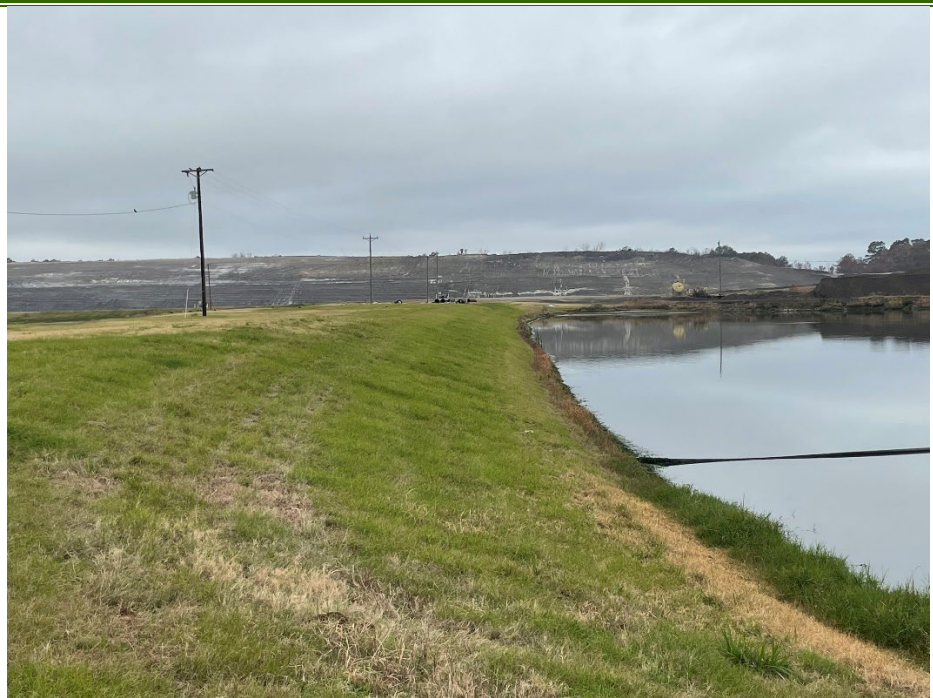
South levee, inside
slope

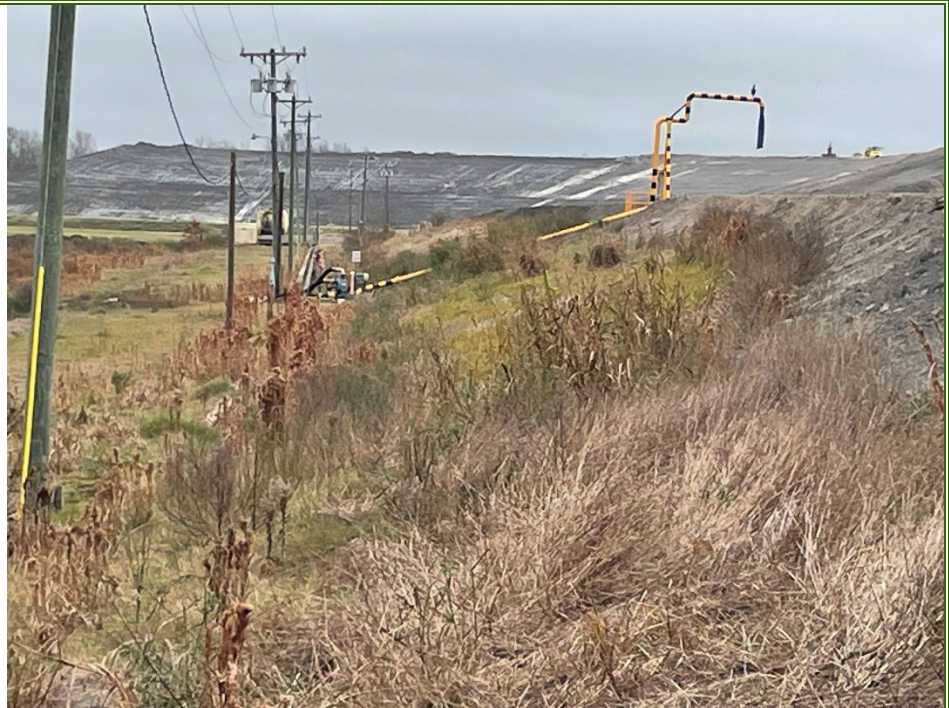
If yes, describe (size of area, location, severity, etc.)	
Findings:	The interior slope was inspected and appeared to be in satisfactory condition. There is excessive vegetation on the interior of the west slope adjacent to Cell 4 of the landfill. Also, there is erosion that needs to be addressed on the interior of the west slope near where the sluice lines go under the roadway between the landfill and the Bottom Ash Pond.
Other observations on the interior slopes:	None.

Excess vegetation on the west slope of the Bottom Ash Pond

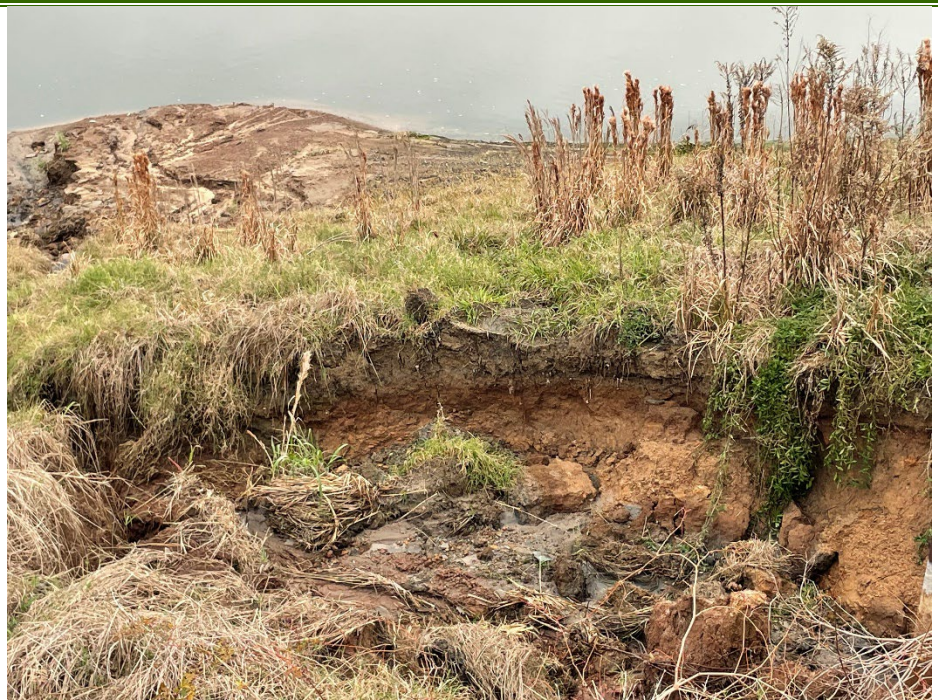
Erosion on the west slope that needs addressing
